# Area in Need of Redevelopment Investigation for Portions of Blocks 5001, 5002, 5004 & 5005 on State Street | Township of Teaneck, New Jersey

Prepared on behalf of The Township of Teaneck Planning Board by  
PHILLIPS PREISS GRYGIEL LEHENY HUGHES LLC | Planning & Real Estate Consultants

May 2022

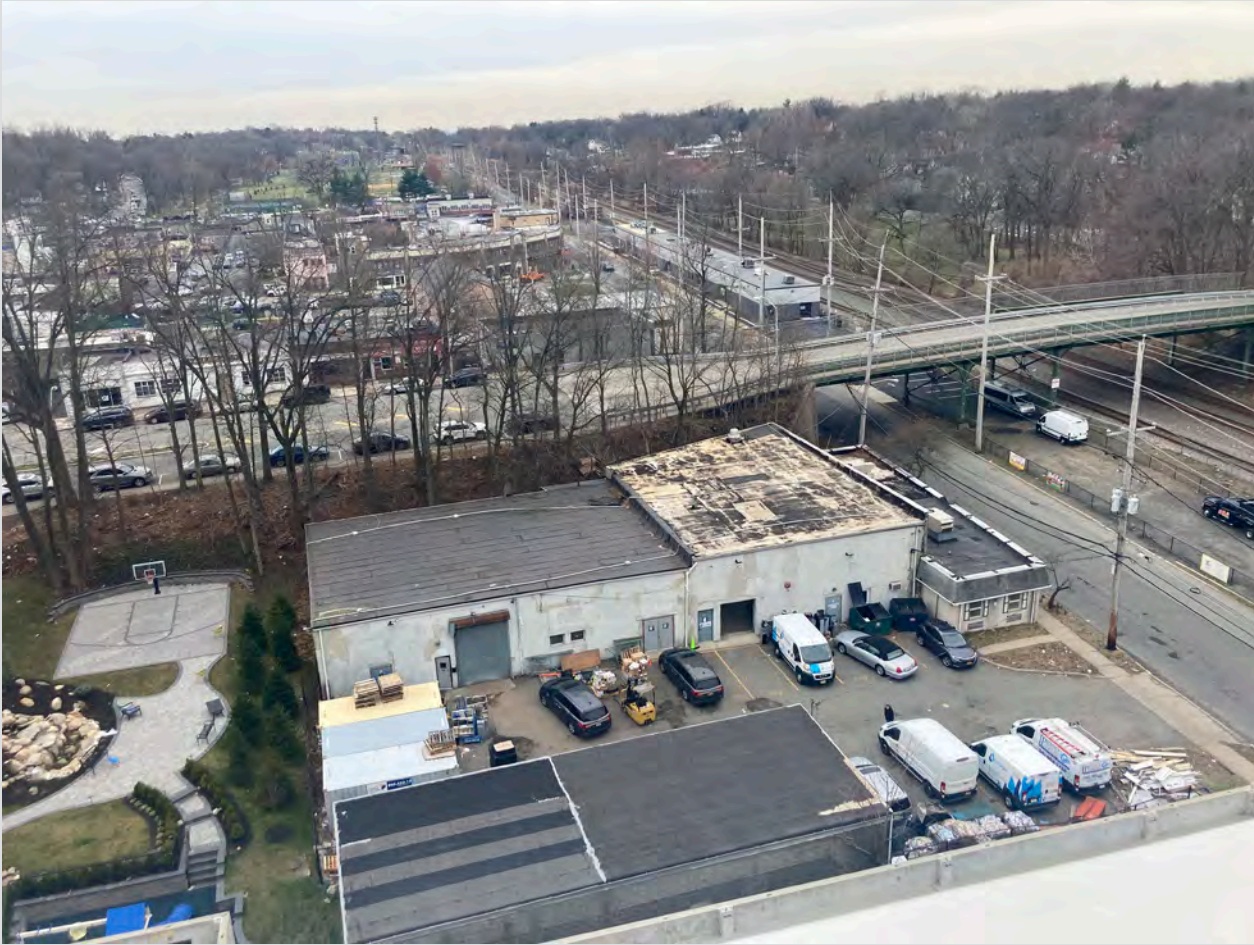
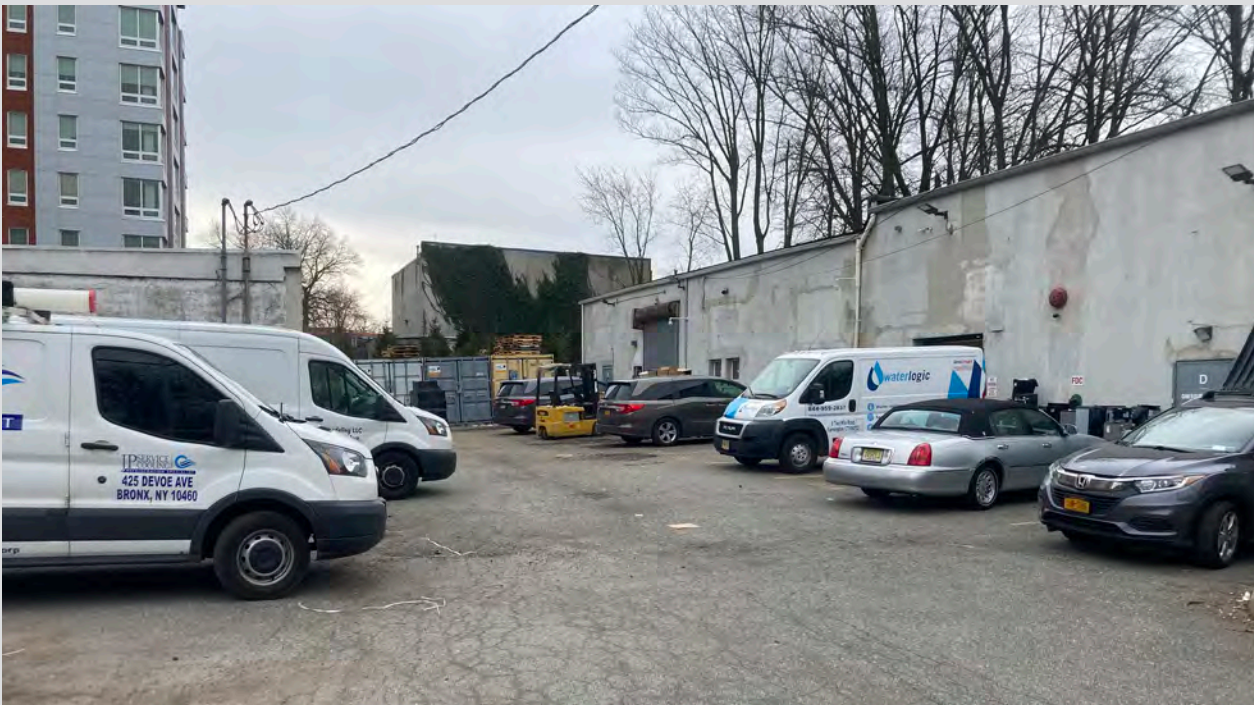
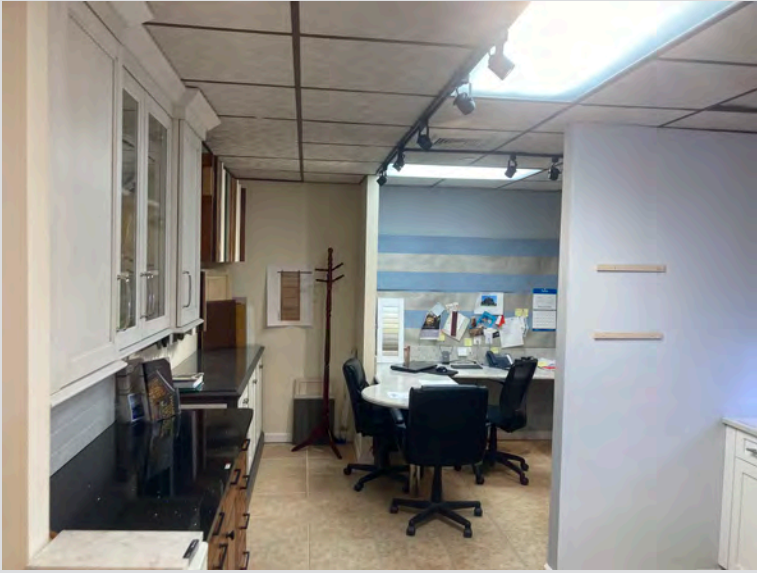
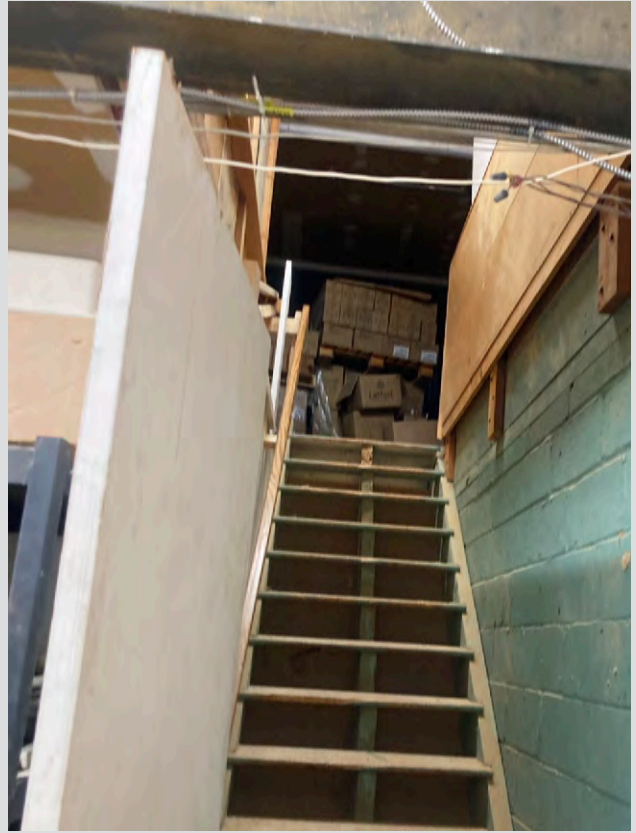
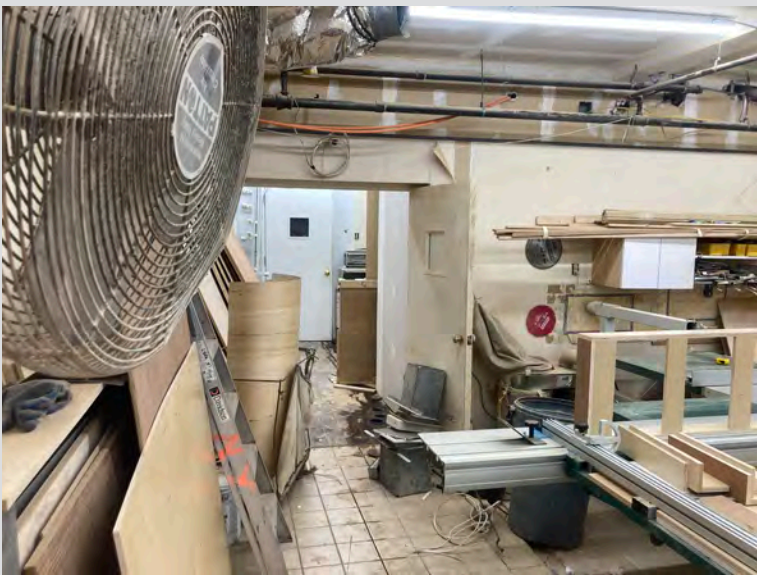
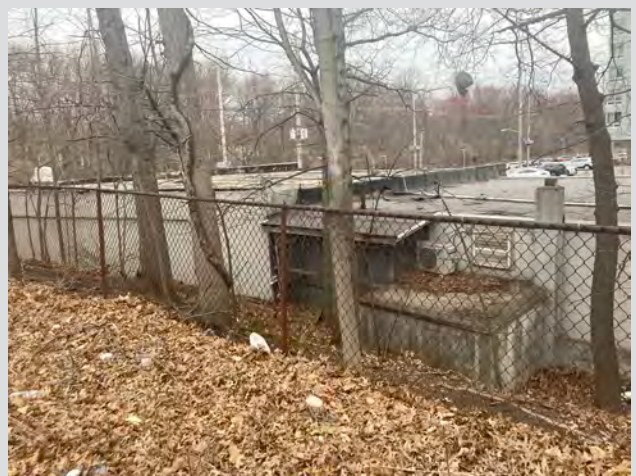
**Figure 1: Block 5001, Lot 4 | 1465 Palisades Avenue**

The existing parking area additionally lacks in interior landscaping, lighting and other design elements to facilitate safe and efficient circulation. The parking area is further in need of repair in many areas, with numerous cracks in the pavement and potholes that are un conducive to an attractive visual environment.

As such, the present layout and design of the property represent an obsolete and faulty design that poses safety concerns. The current conditions are also incompatible with the recent trends in the transformation of the Palisade Avenue and State Street corridors and inconsistent with the Township's visions for the area. The property conditions are detrimental to the public welfare and thus satisfy criterion "d."

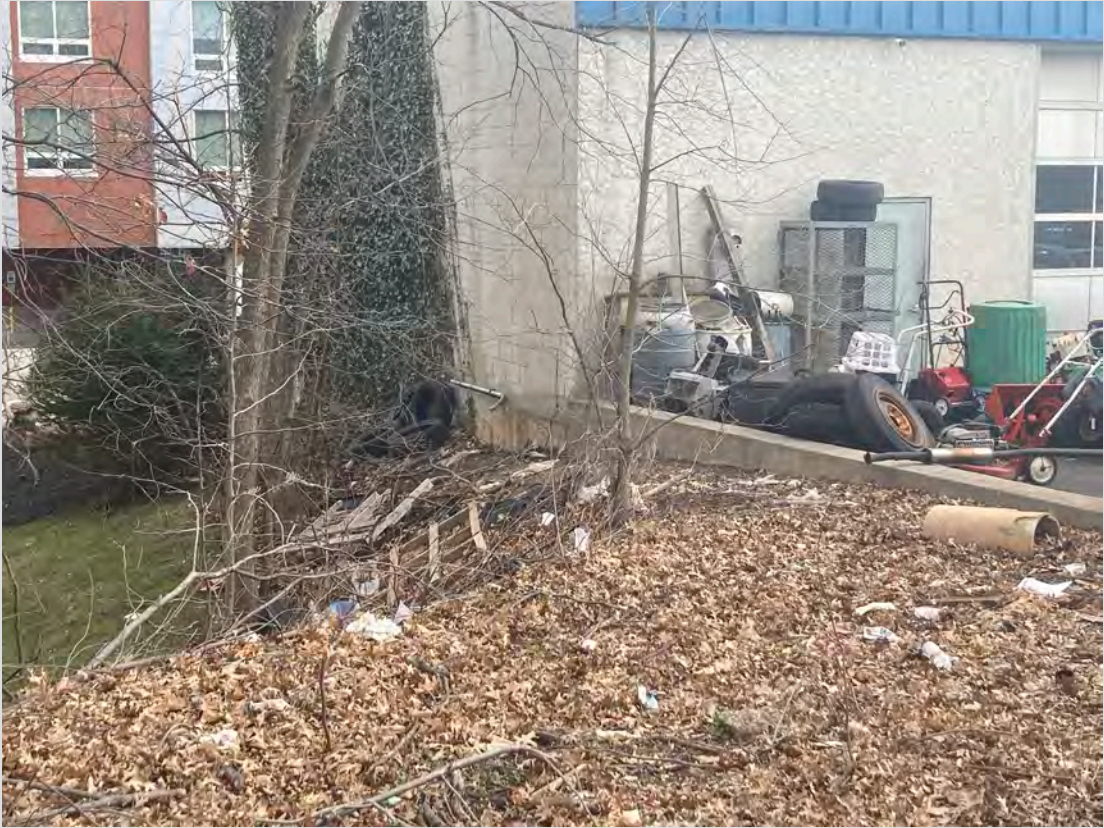
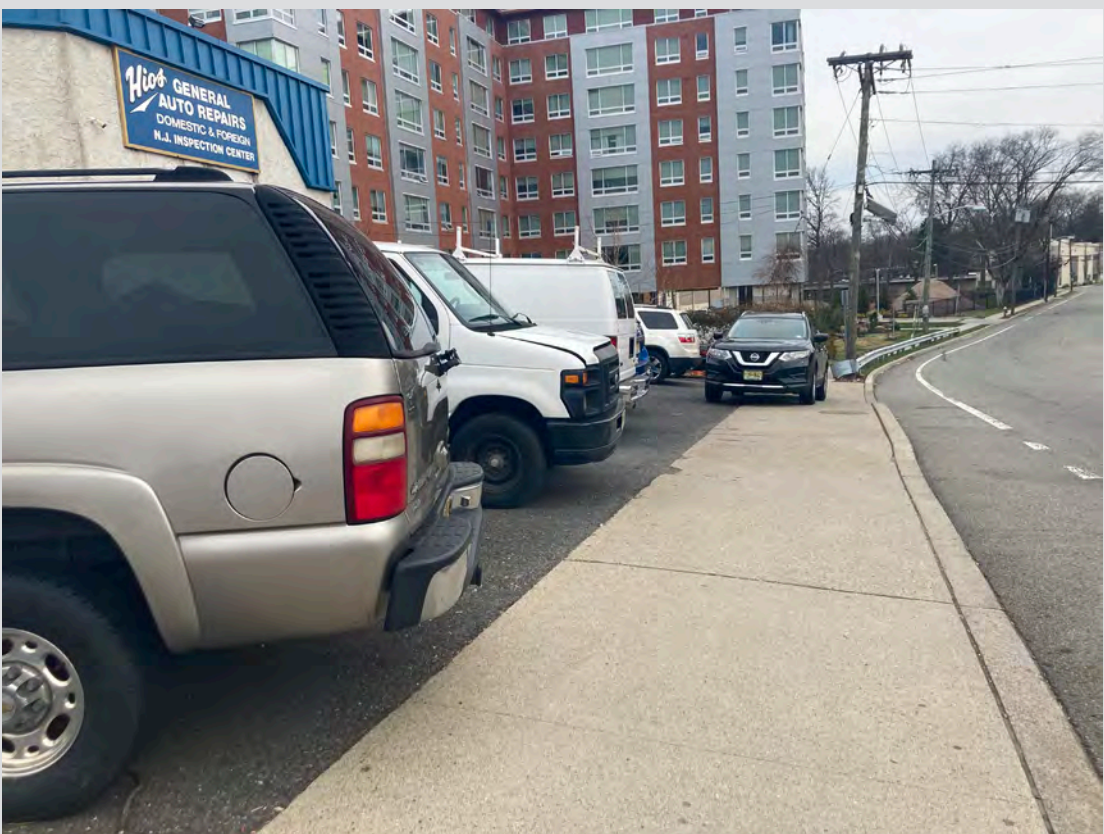
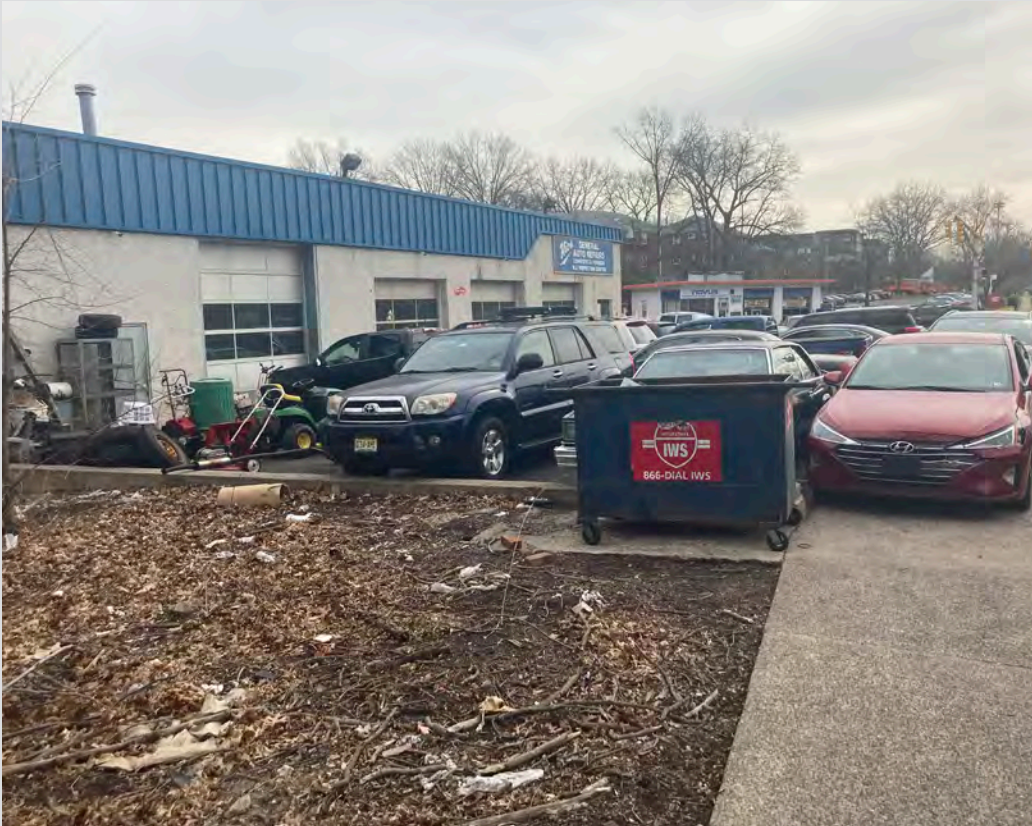
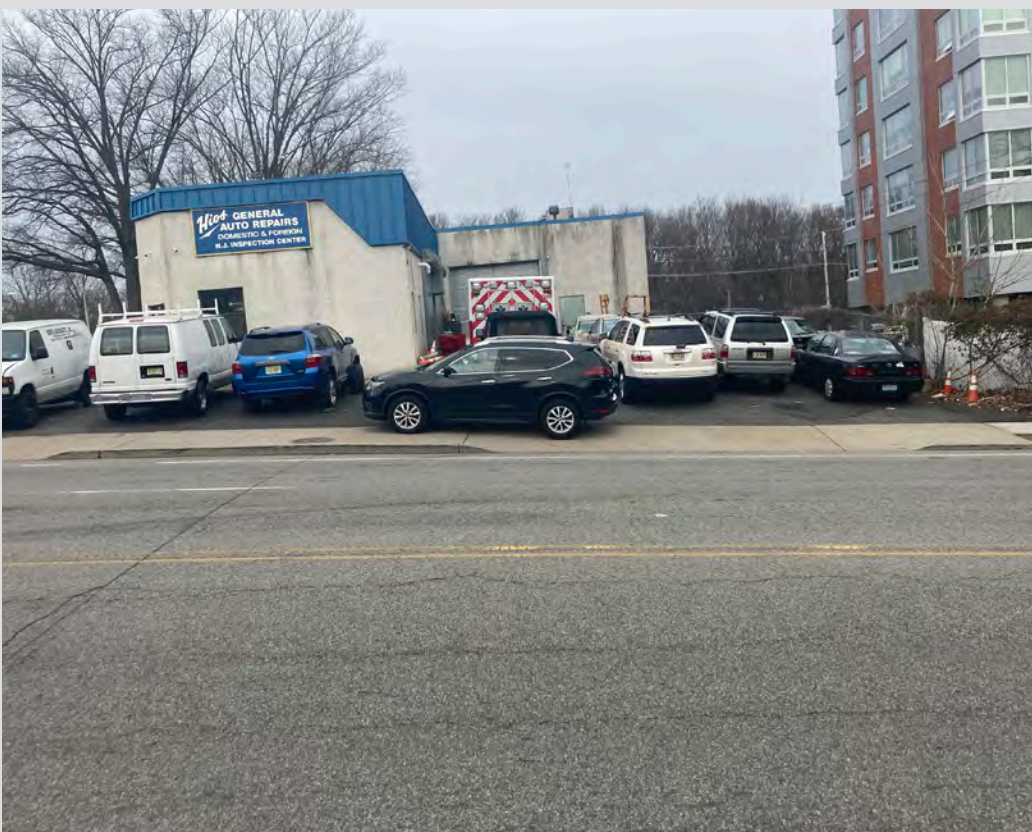
**Figure 2.1: Block 5001, Lot 2 | 153 State St**

Block 5001, Lot 2 is an approximately 0.254-acre site that is currently improved with the Hios-General Auto Repairs use. It is improved with a single-story commercial building with garage bays and surface parking surrounding the building. The site is located at the intersection of State Street and Queen Anne Road.

As illustrated in the photographs included in the Appendix, there is no separation between the surface parking areas and the adjacent the sidewalks with the exception of a small planted island at the corner. Cars undergoing repair are parked in a haphazard manner throughout the site and spill onto the public sidewalks, which impedes the sidewalk path for pedestrians. The business also parks customer vehicles along State Street, indicating an insufficient supply of off-street parking. Tires and equipment litter the westerly portion of the site without any screening or organized storage.

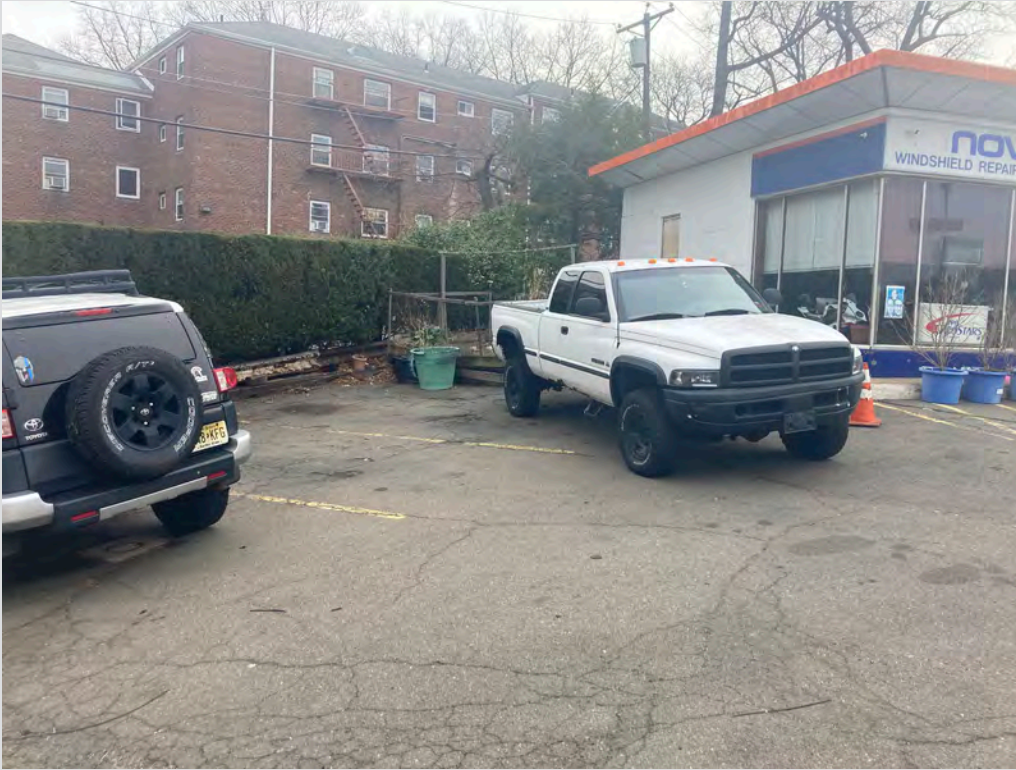
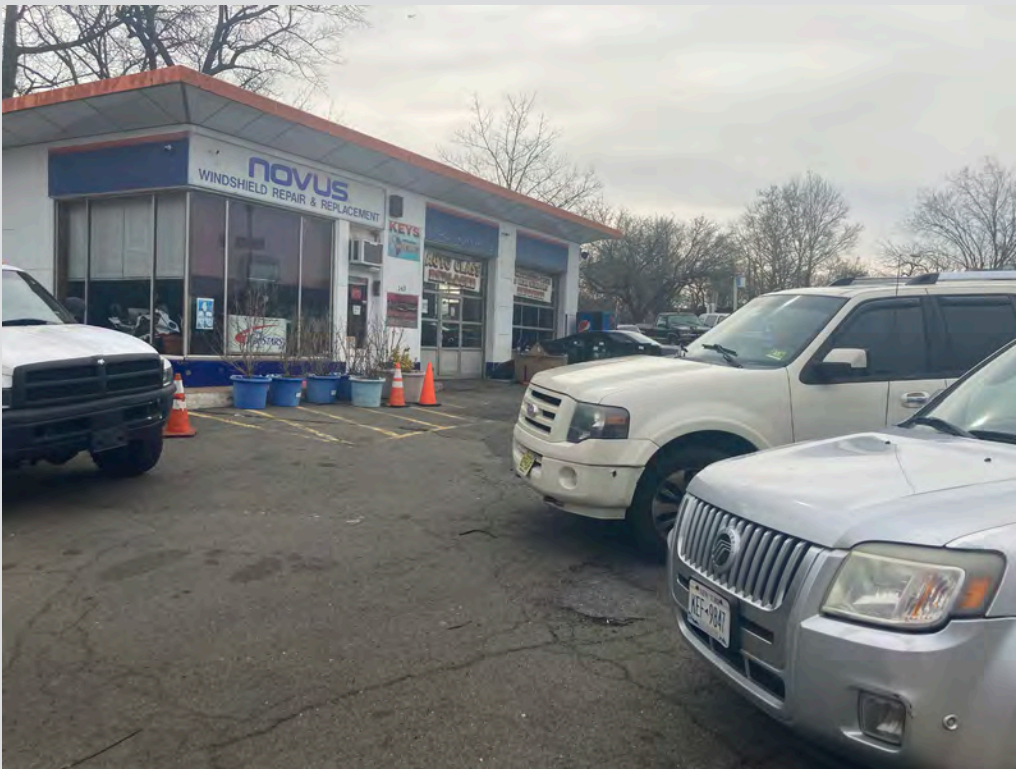
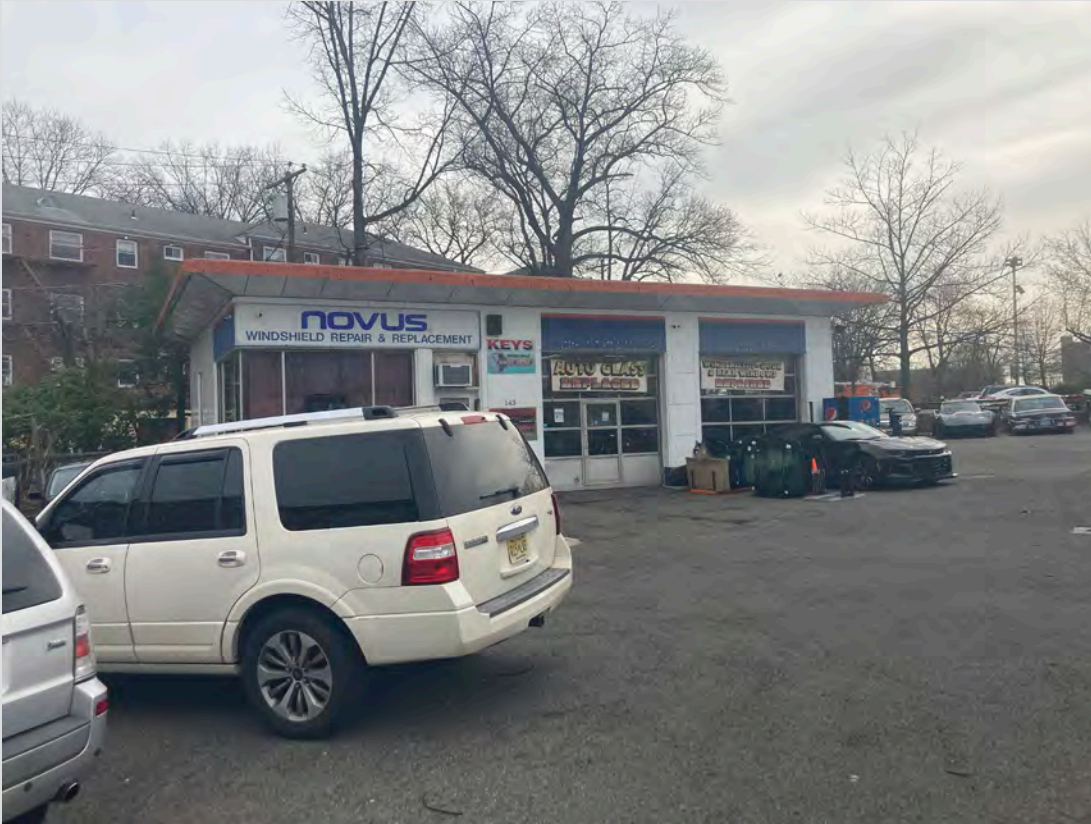
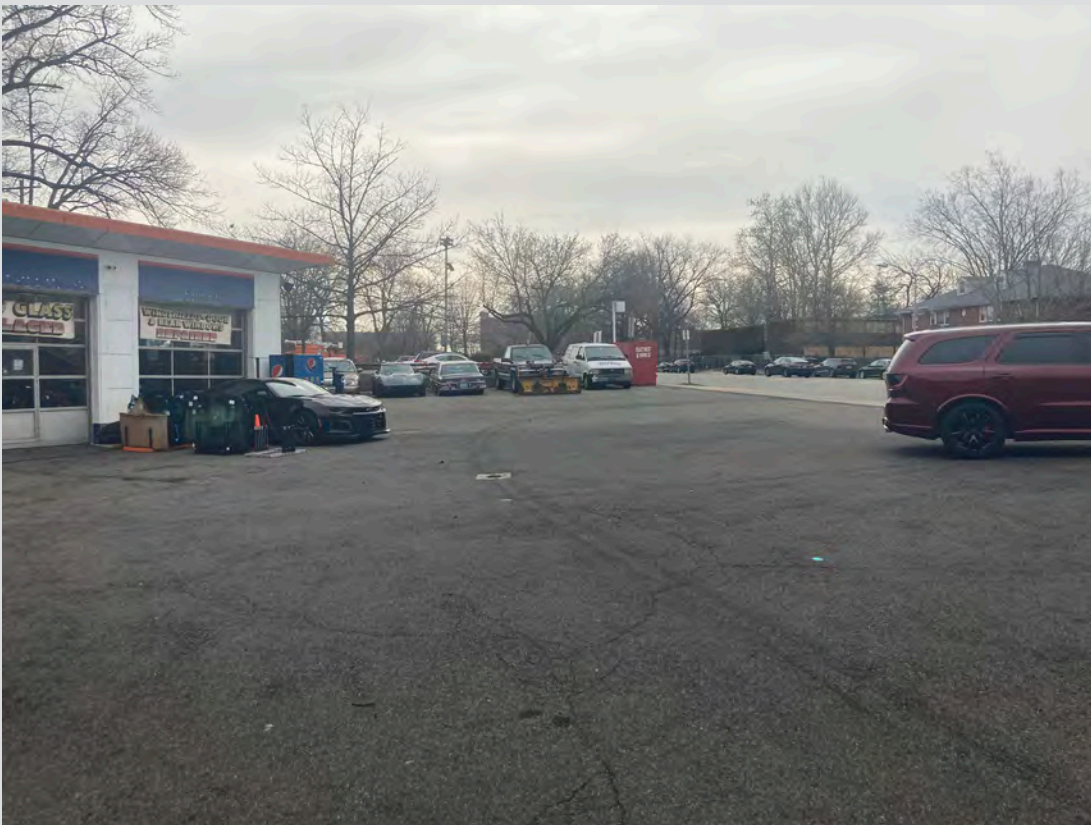
**Figure 2.2: Block 5002, Lot 26 | 143 State St**

Block 5002, Lot 26 is currently utilized as the Novus Windshield Repair & Replacement business, including a single-story commercial building and surface parking. The site totals 0.287 acres and is a corner lot with frontage on both Queen Anne Road and State Street. Similar to other corner commercial lots, the surface parking areas largely open directly to the sidewalk without any buffer or physical separation.

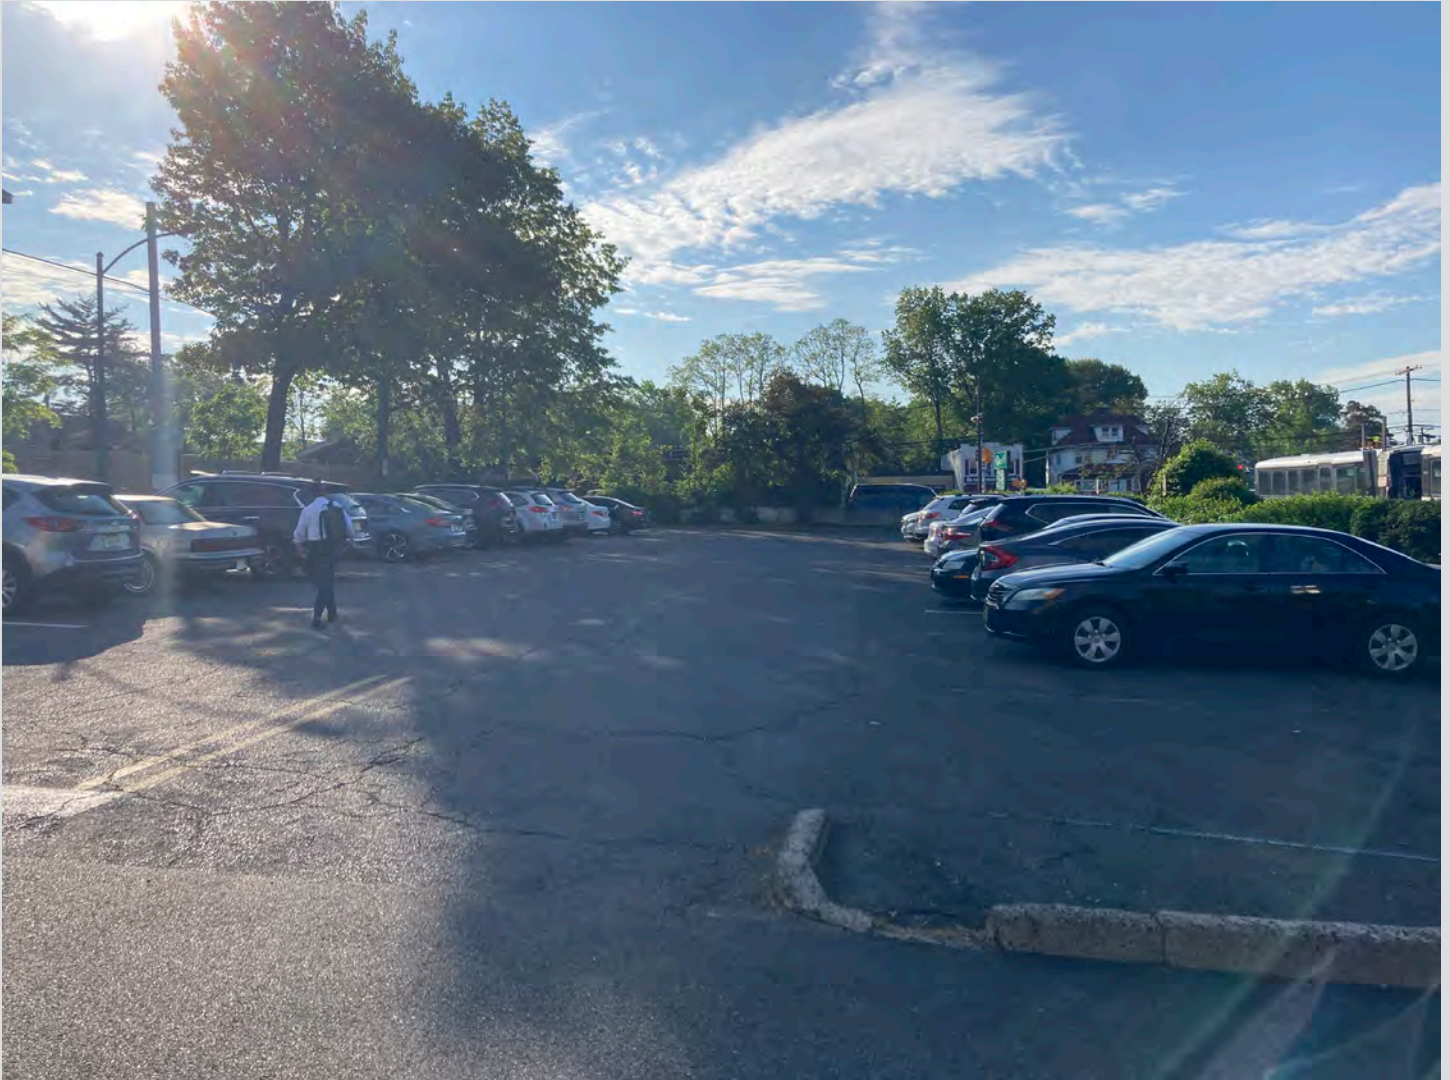
**Figure 3.1: Block 5002, Lot 20 | 29 State St**

As such, the type of layout and design exhibited by the municipal parking lots on Block 5002, Lots 20 & 25 are an obsolescence that is detrimental to the compact, walkable, mixed-use environment of the State Street corridor that the Township envisions. Under current conditions, the excessive land coverage and faulty arrangement and design of the property are inconsistent with the Master Plan vision for the State Street corridor, and thus the morals and welfare of the community.

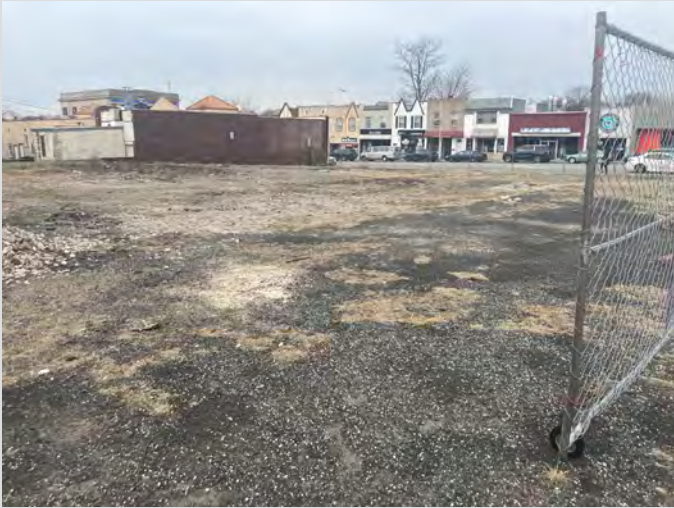
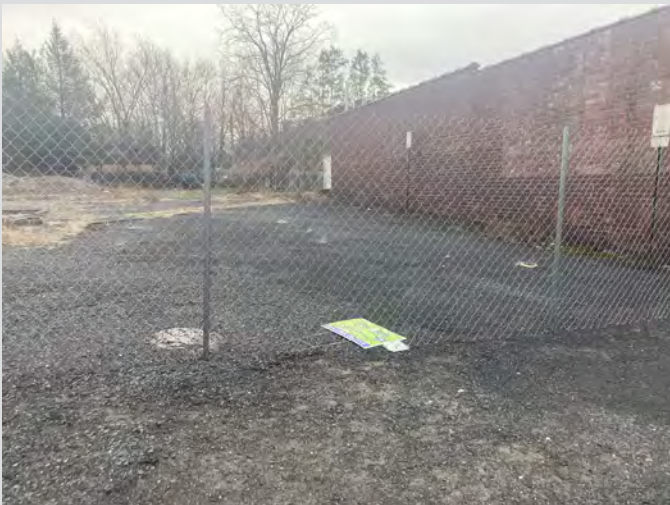
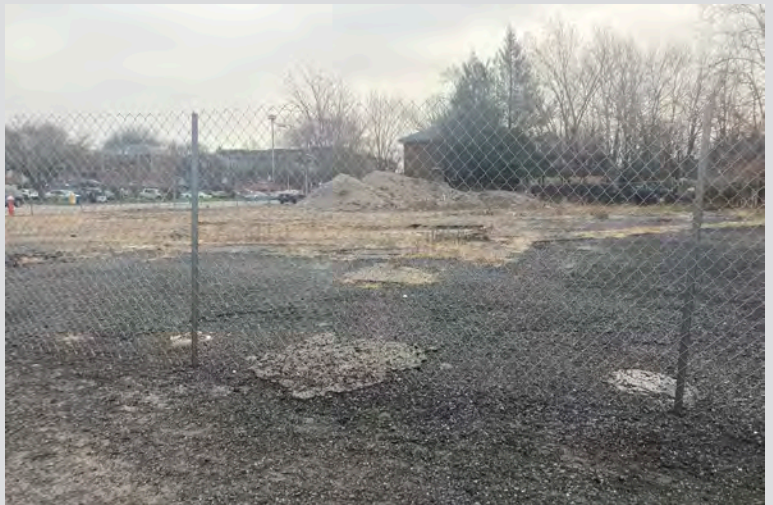
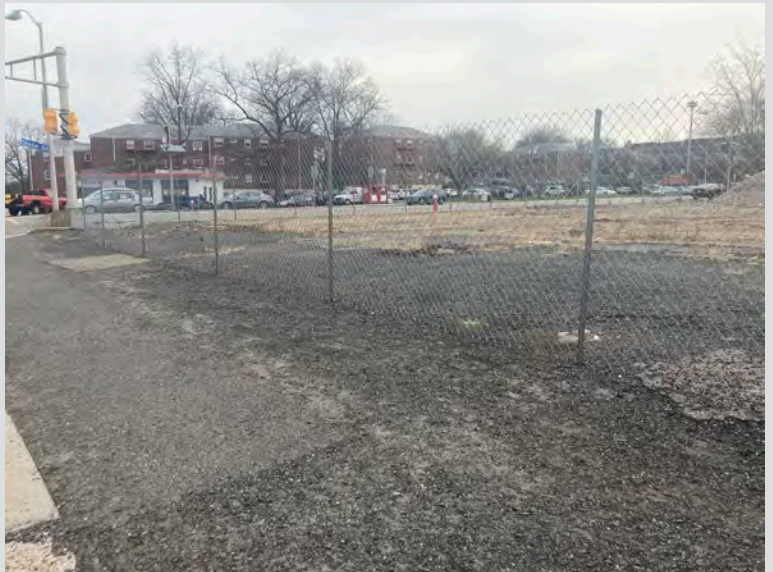
**Figure 5: Block 5004, Lot 1 | 140 State St**

This parcel was formerly improved with a gas station, which the Master Plan noted had contributed to the gap in retail frontage that characterizes the rest of the area along Queen Anne Road and resulted in a lack of cohesion. The gas station use was subsequently discontinued by the time of the 2011 Master Plan Reexamination Report. The parcel was subsequently granted approval in 2013 by

Currently, there are remnants of the previous improvements, including paved areas and debris from the demolition. The site is in a state of poor maintenance, with pavement in disrepair, overgrown weeds, and no landscaping to screen the site. The property presents a departure from the streetwall and pedestrian-oriented environment formed along Queen Anne Road and State Street and are detrimental to the aesthetics of the neighborhood. Particularly with its location at the corner of State Street and Queen Anne Road, the current condition of the site is uncondusive to advancing the visions for the Queen Anne Road and State Street corridors as described in the Township’s Master Plan.

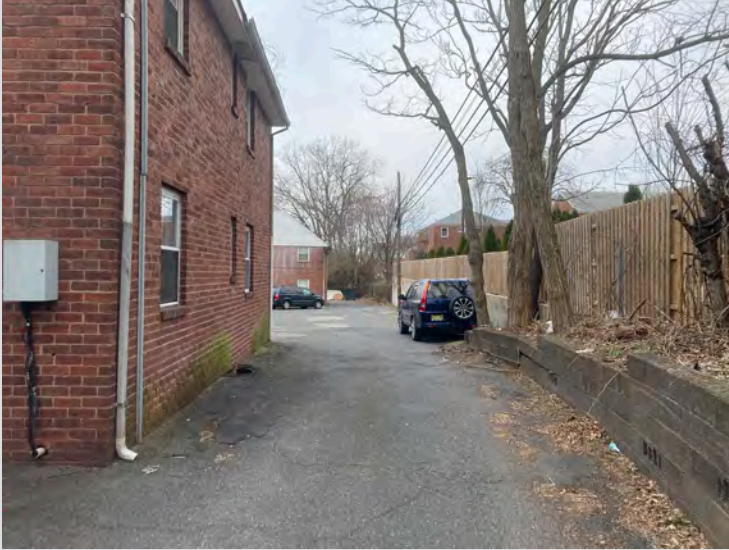
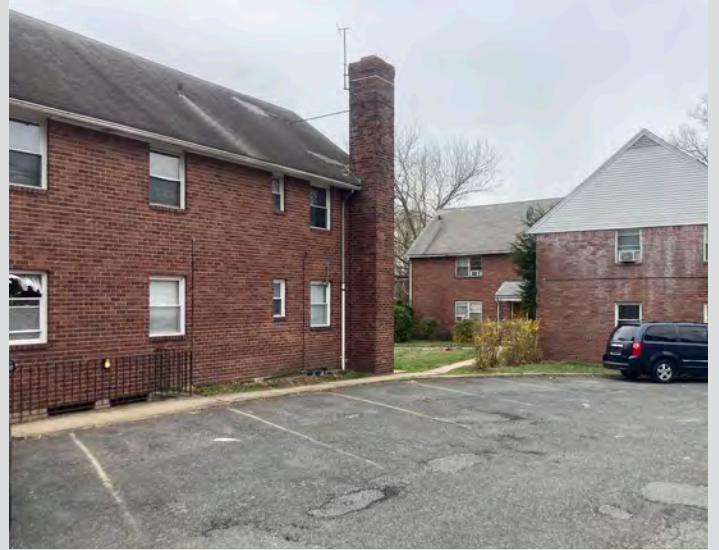
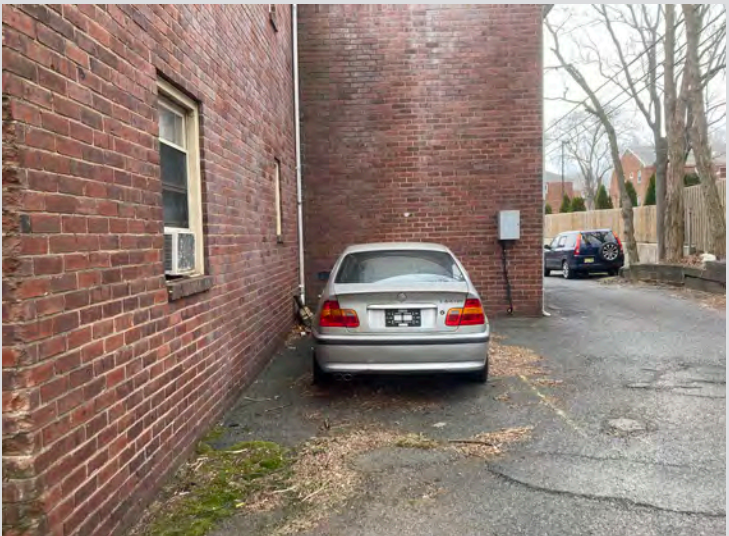
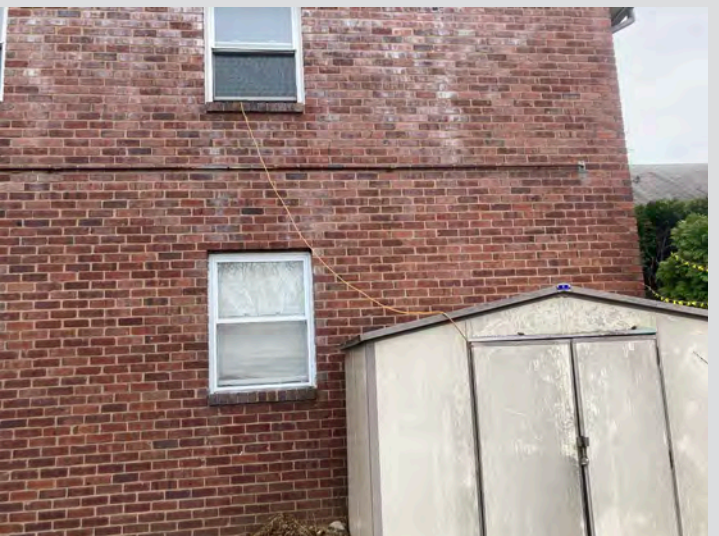
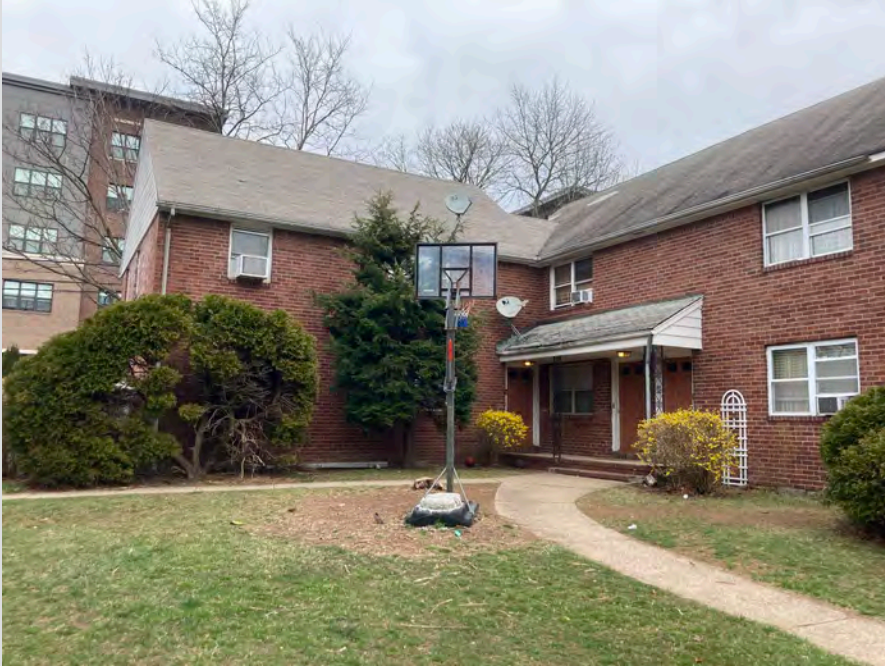
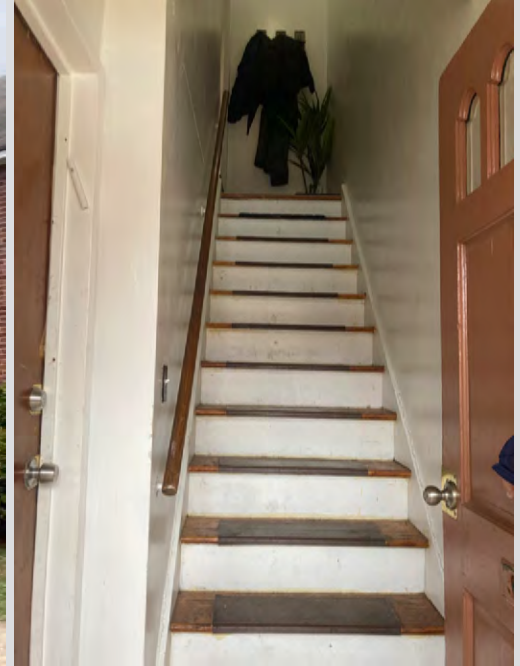
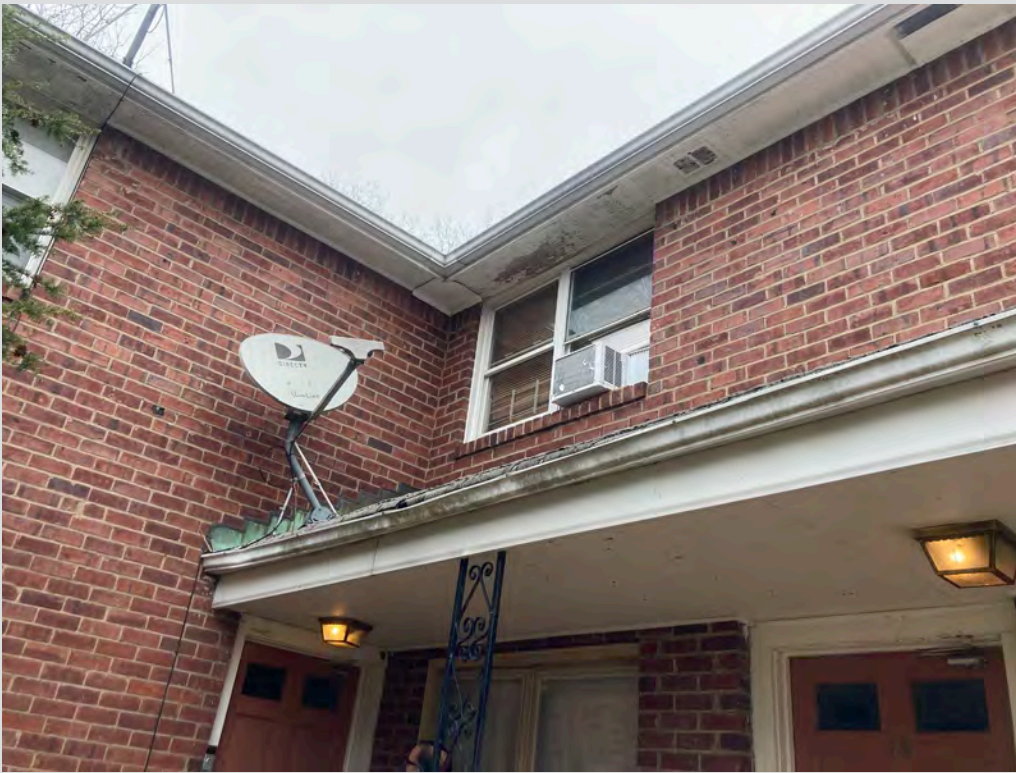
**Figure 8.1: Block 5002, Lot 22 | 49-71 State St**

This multifamily development is outdated and obsolete in terms of its design and layout. The buildings consist of dwelling units with minimal separation between entrances connected by narrow and windowless stairways that do not meet modern ADA accessibility standards. The surface parking area is unstriped and haphazardly arranged. An unregistered vehicle was observed illegally parked on the site. Further, the dwelling units feature small windows with limited access to light and air and no common amenities or open spaces for the recreational enjoyment of residents. The obsolete design of the buildings is detrimental to the quality of life of residents. Additionally, HVAC units and other equipment are attached to windows and building facades without screening, which is detrimental to the visual environment of the site and the streetscape. An electrical cord running from a residential window to an outdoor storage shed was also observed.

In summary, the design and layout of the buildings are obsolete by today’s standards, while the aging infrastructure and utility systems currently pose concerns for public health and safety. As such, the current conditions are detrimental to the public welfare and qualify under criterion “d.”

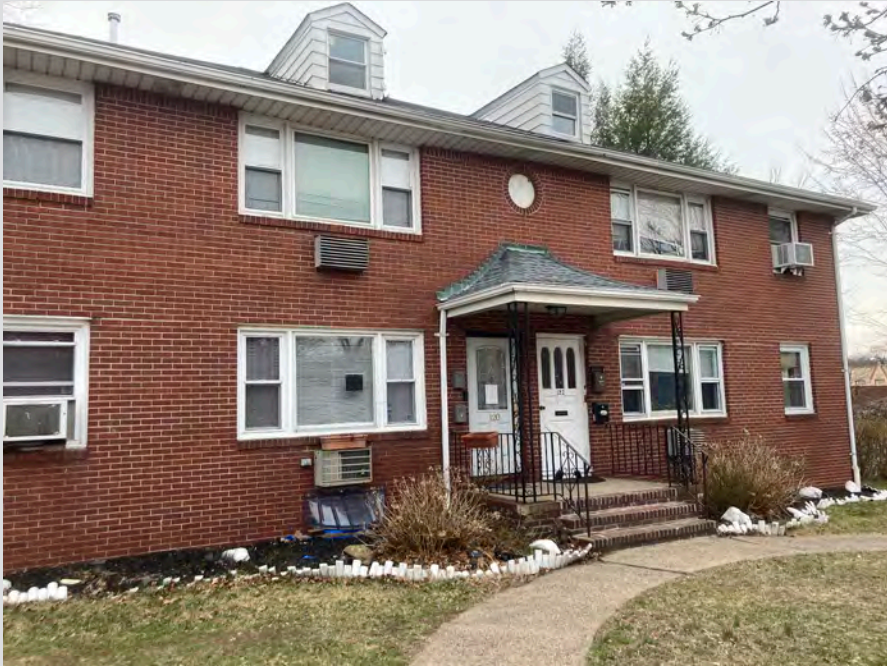
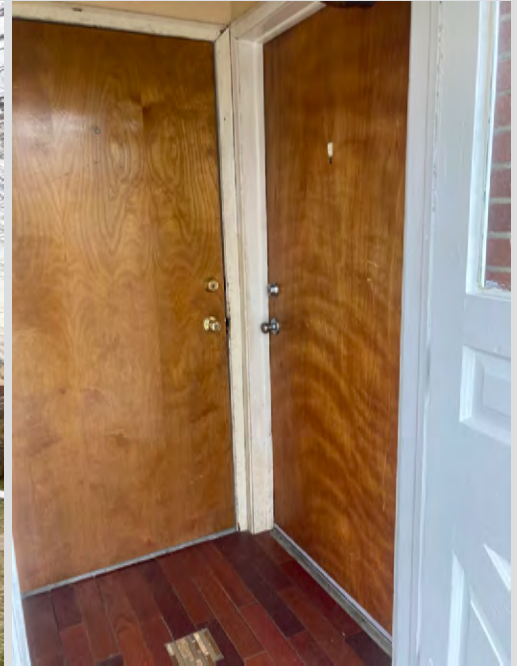
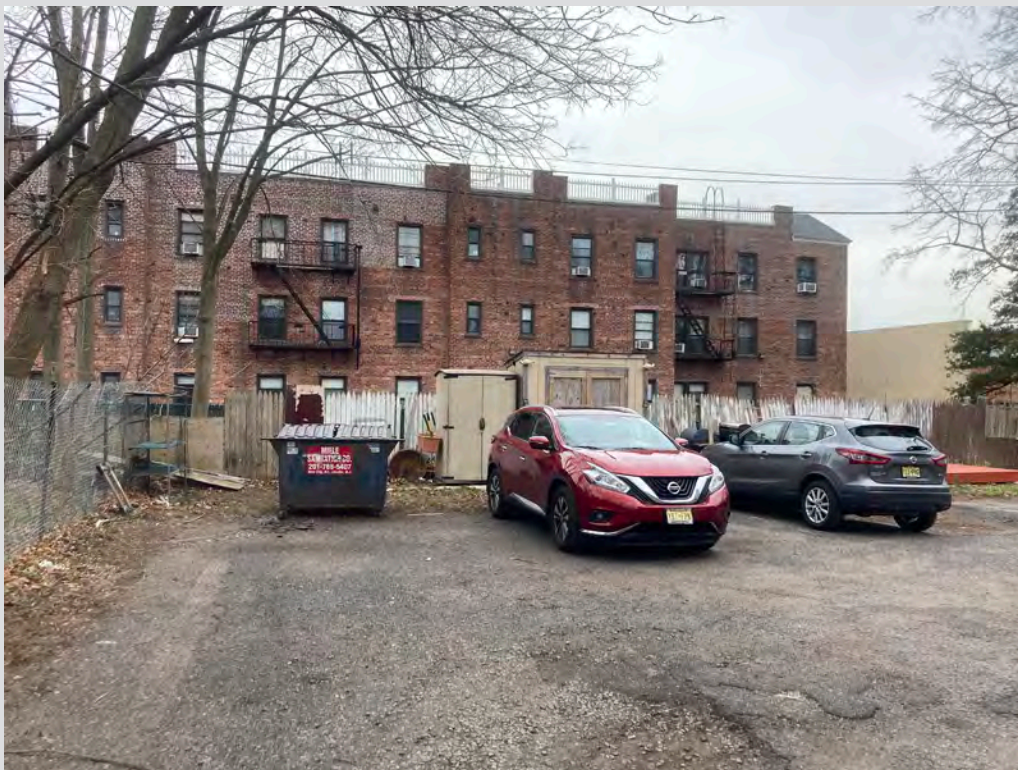
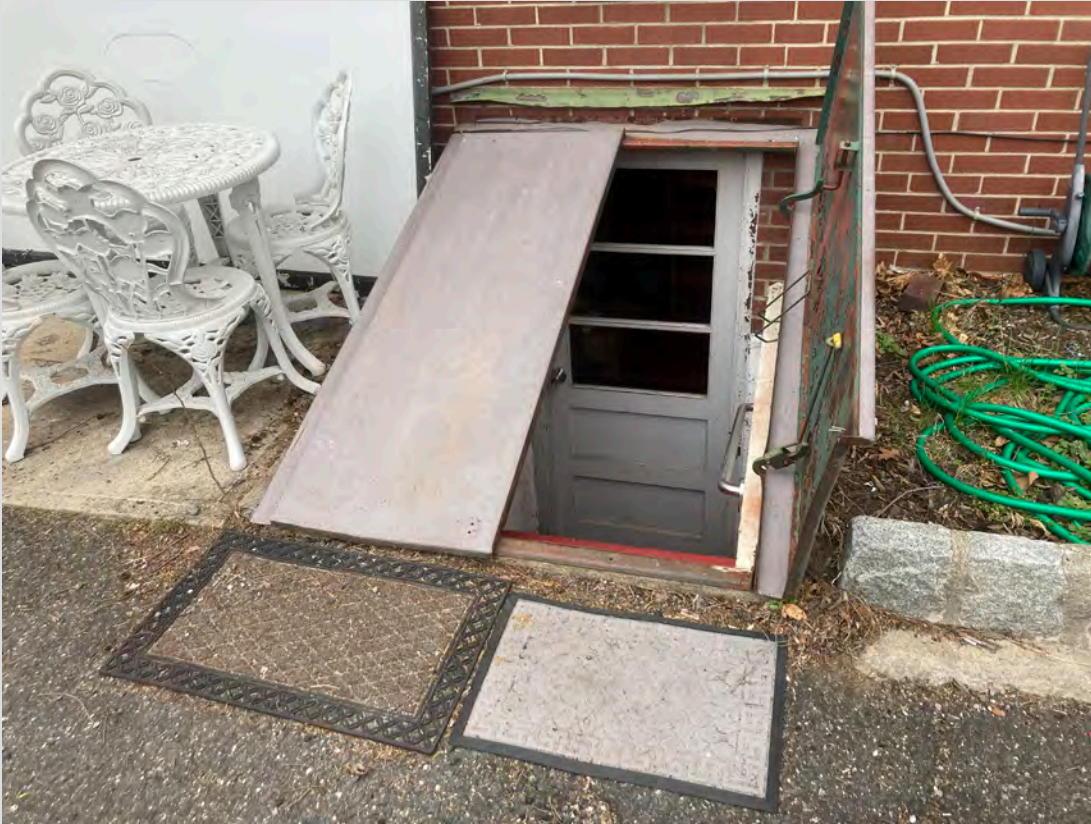
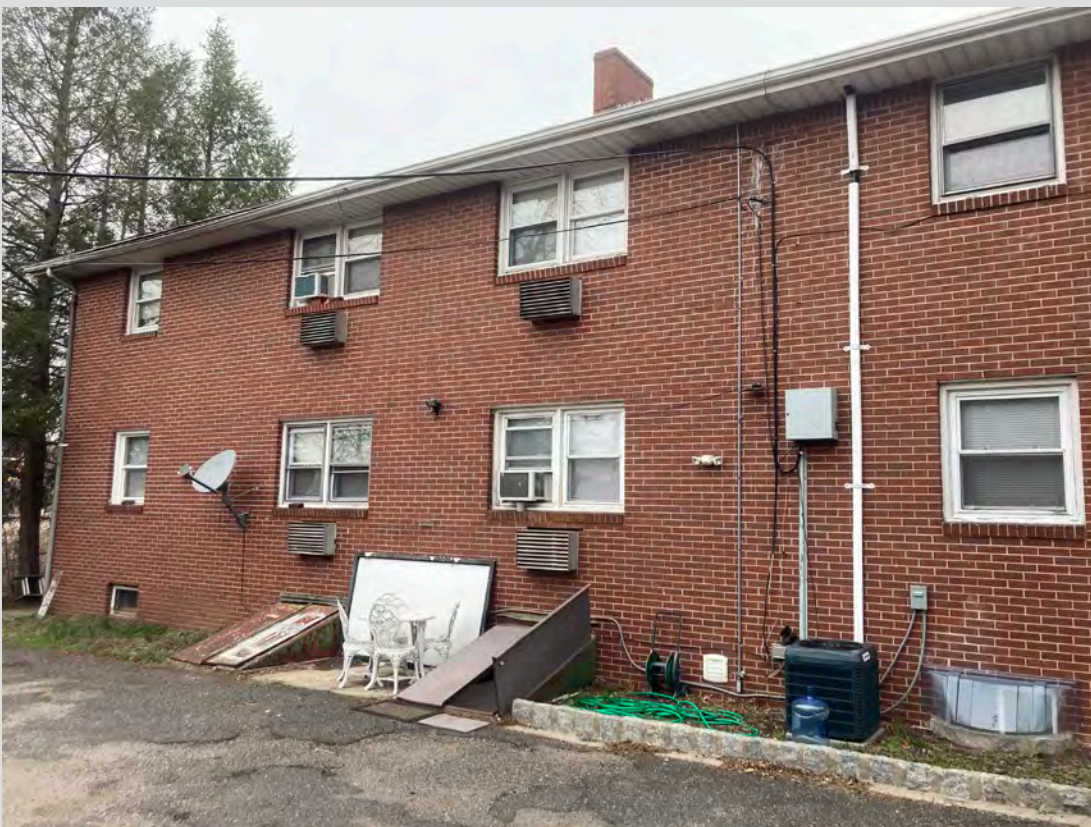
**Figure 8.2: Block 5004, Lots 2 & 2.C0001-2.C0004 | 120-122 State St**

Due to the age of the buildings and their infrastructure and utilities, the current conditions have also caused public safety concerns. Recently in 2021, the condominium building on Block 5004, Lots 2-2.C0004 experienced a gas leak incident and also witnessed a medical emergency after an occupant fell outside from the building. In addition, various materials and equipment are stored in the rear of the property in an unsightly manner.

In summary, the design and layout of the buildings are obsolete by today’s standards, while the aging infrastructure and utility systems currently pose concerns for public health and safety. As such, the current conditions are detrimental to the public welfare and qualify under criterion “d.”
